# Manhole Inspection Summary

Manhole # S31SS\_037MH

Insp Date: **5/2/07 11:21 AM**

**Location** Address: **2743 HUNTINGDON AVE**

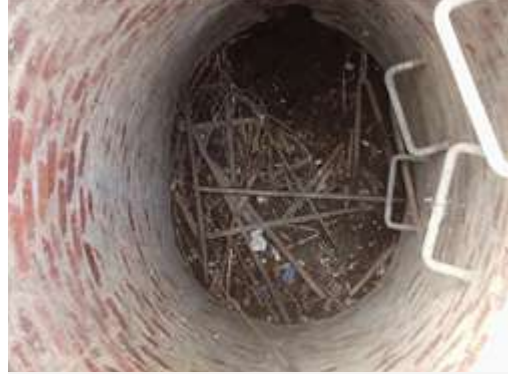
Top View

Channel debris.

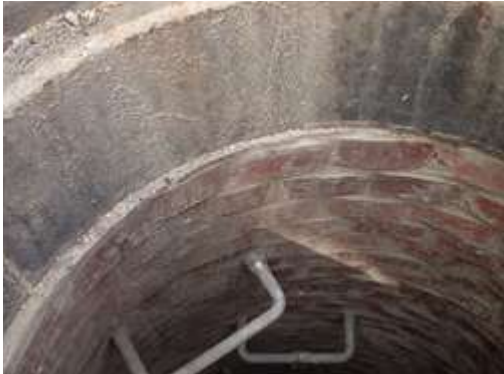
Defect

Frame leaks. Adjustment infiltration - other side.

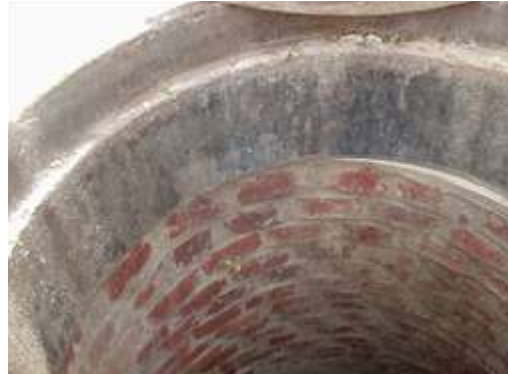
Defect

Frame leaks. Adjustment infiltration.

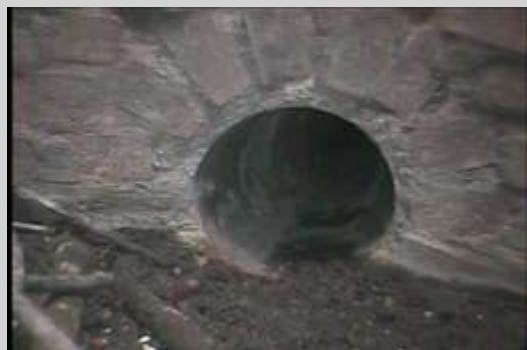
Pipe Out @ 12 O'Clock

Deposits: ☐ None ☒ **Mud** ☐ Sludge ☒ **Debris** ☐ Grease

Deposits Extent: **Light**
